A FINE WRECK IN SHALLOW WATER: INVESTIGATION INTO,
AND CONSERVATION OF, A HEAVILY DISTURBED
18TH CENTURY BRITISH WEST INDIAMAN,
THE SOLDIER KEY WRECK

A thesis submitted to the Department of Anthropology
College of Arts, Social Sciences, and Humanities
The University of West Florida
In partial fulfillment of the requirements for the degree of
Master of Arts

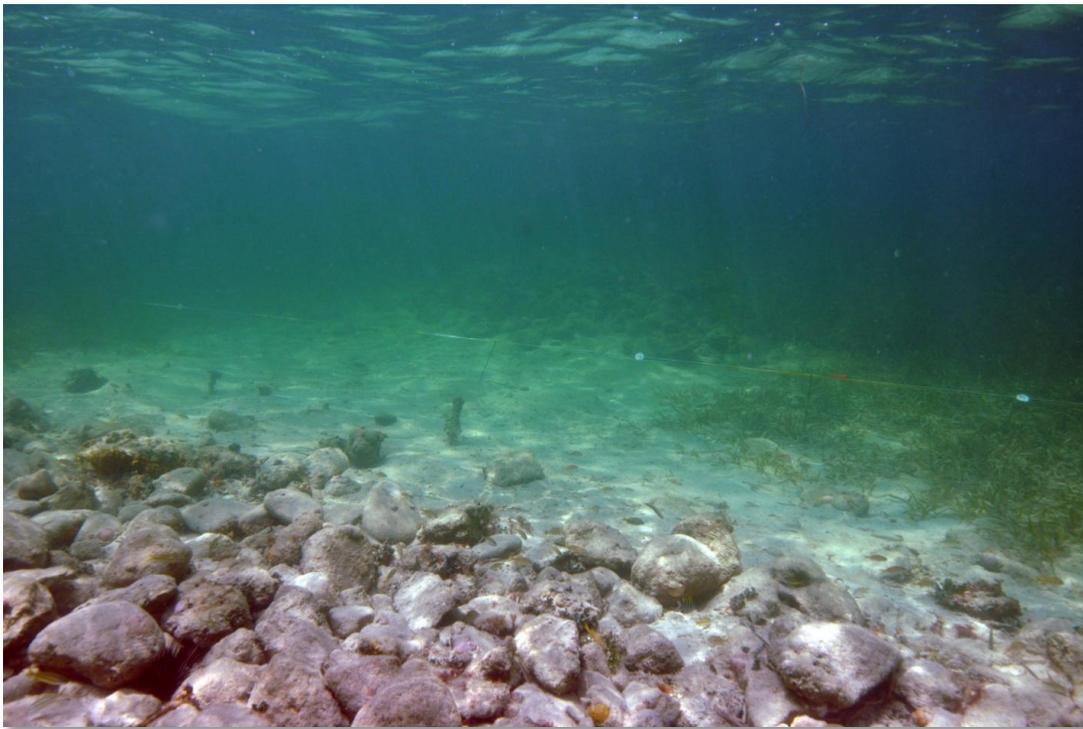
FIGURE 2. The site showing the exposed drift pins, the baseline, shallow depth, and the ballast piles. (Courtesy of the National Park Service, 2012.)

Archaeologists laid out a single baseline over the site roughly parallel to the exposed drift pins. Copper pins provided by the NPS anchored the baseline at each end and served as the datums for geo-referencing the site. The baseline was elevated roughly .5 m (1.64ft.) above the site. The baseline consisted of a nylon string stretched taught with a fiberglass metric tape reel zip-tied to the nylon line to reference the locations of artifacts and features, delineate the excavation units, and serve as known points from which the team could trilaterate the site. At every two meters the crew placed a line “cookie,” a circular piece of plastic that attached to the line via tension often used by technical divers, which they would then use as a known reference point in taking measurements. The overall length of the baseline was 20 m (65.62 ft.). The 0 meter end of the baseline and datum was to the western end (toward land) and the 20 meter end and datum was to the east (seaward).

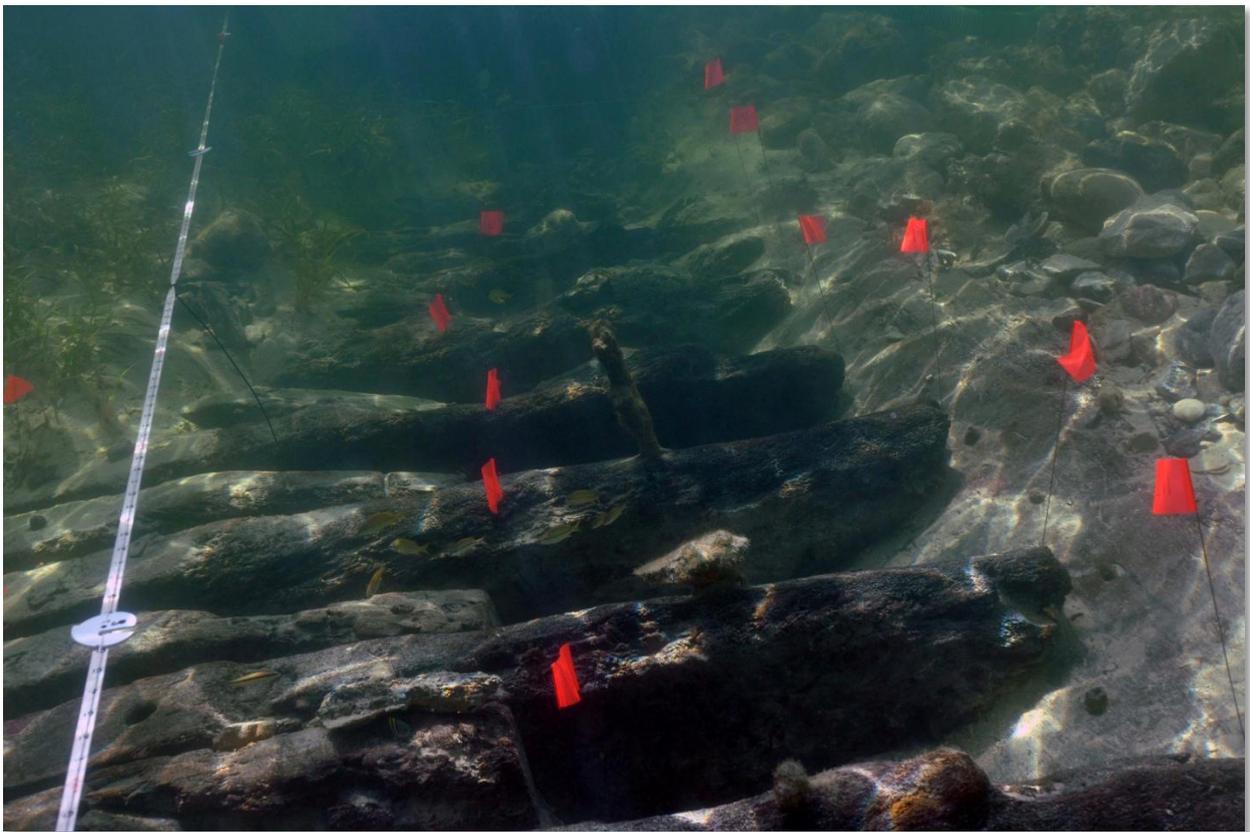
FIGURE 6. Baseline, “cookies,” and pin flags used in trilateration. (Courtesy of the National Park Service, 2012.)

The crew mapped the site using trilateration: using the line “cookies” placed on the baseline, the crew took two measurements, one each from two separate “cookies” to numbered pin flags placed at areas researchers deemed key to the site, including the edge of the hull, ends of individual timbers, fasteners, and any other diagnostic areas (Figure 6). The pin flags remained on the site until the crew completed all of the mapping. Then, using those known distances, the crew created a scale drawing of the site.

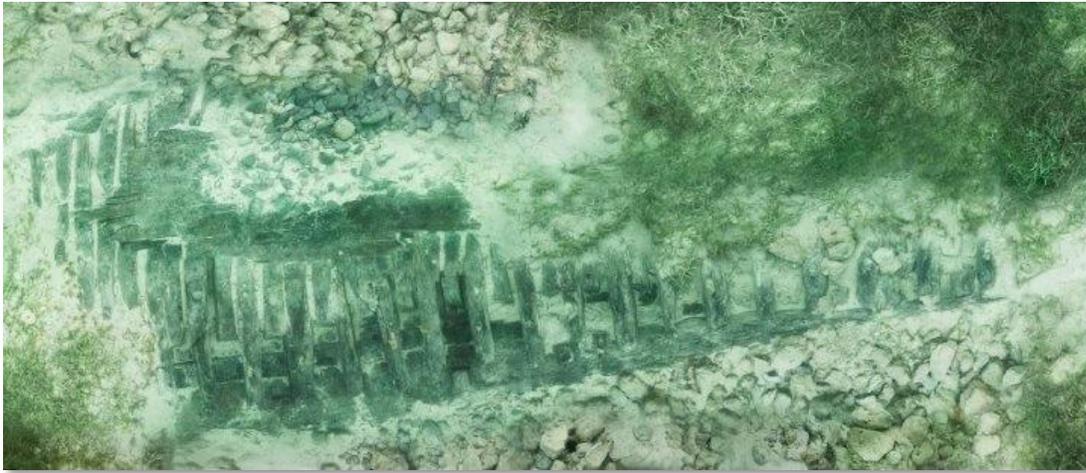
FIGURE 7. Photomosaic of the site after excavation. (Courtesy of the National Park Service, 2012.)

number of photos needed to make accurate before and after photo mosaics. Fortunately, after much work, two photo mosaics of the exposed site were ultimately constructed: one by Charles Lawson and one by Susanna Pershern. Archeologist Andres Alberto checked the accuracy of the photo mosaics against the scale site plan the crew created with favorable results (Figure 7 and Figure 8).

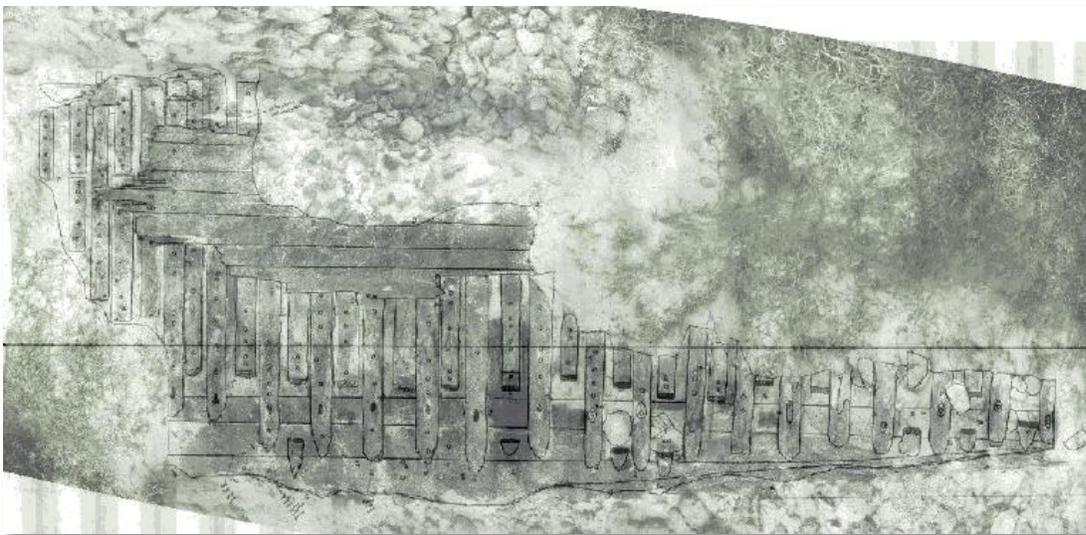
FIGURE 8. Overlay of the site plan drawn at Stiltsville over the photomosaic from the SRC. (Courtesy of the National Park Service, 2012.)

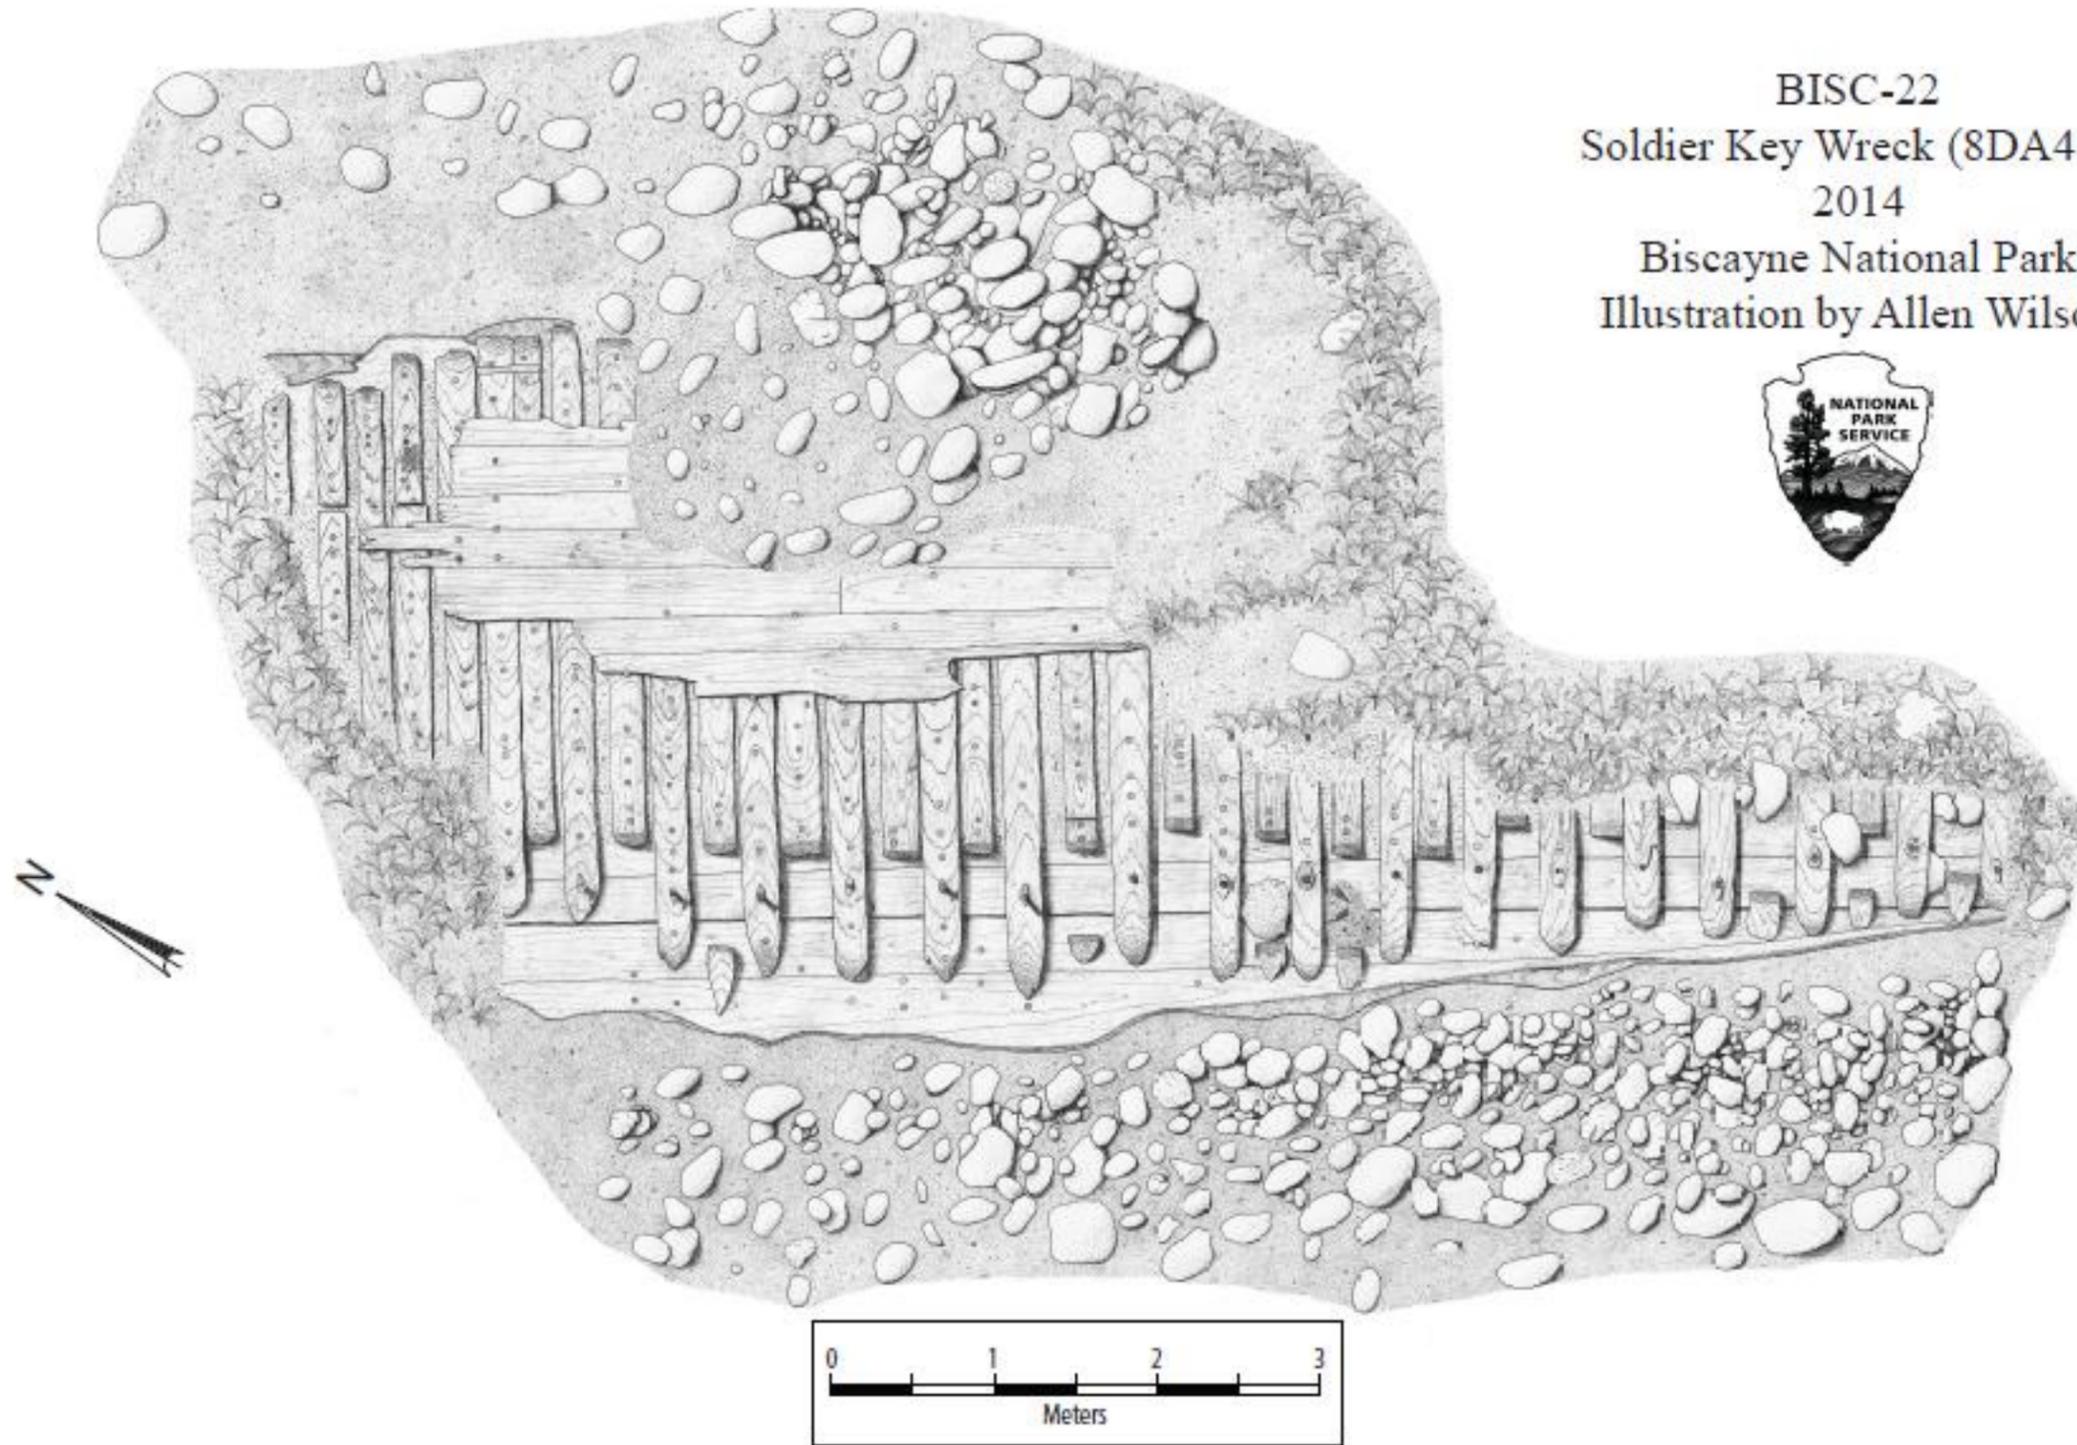
BISC-22
Soldier Key Wreck (8DA416)
2014
Biscayne National Park
Illustration by Allen Wilson

FIGURE 9. Soldier Key Wreck site plan as seen in 2012. (Illustration by author, 2014.)

During excavation, researchers exposed 13m (42.65 ft.) of articulated hull remains. On the southern end of the site, divers exposed an 11m (36.09 ft.) long keel made of a single piece of white oak (*Quercus alba*) (Amy Mitchell-Cook 2012, elec. comm.) with no visible scarfs, along with the remains of the port side of the vessel. The sided dimension of the keel tapered slightly from 31 cm (12.20 in.) on the western (bow) end to 29 cm (11.42 in.) on the eastern (stern) end. Unable to expose any more of the keel, the molded dimension is unknown. Hall's notes, however, include a small drawing (Figure 10) that suggests the keel is composed of two timbers of equal size, 10 x 10 in. (25.4 x 25.4 cm) laminated on top of one another. This arrangement would be unusual and would give the vessel a full 20 inch (50.8 cm) thick keel. While a thinner keel "shoe" was common to protect the keel from groundings, this combination of timbers to form the molded dimension of the keel is uncommon. This lamination could not be verified by the 2012 fieldwork. We also found no section of keel that is as narrow as Hall's notes indicate (10 in. [25.4 cm]).

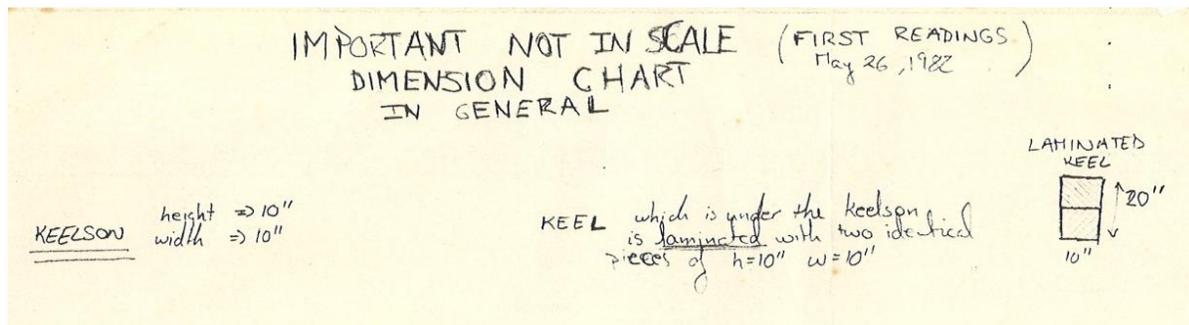
FIGURE 10. Hall's notes and sketch regarding the possible laminated keel. (Courtesy of the National Park Service, 2012.)

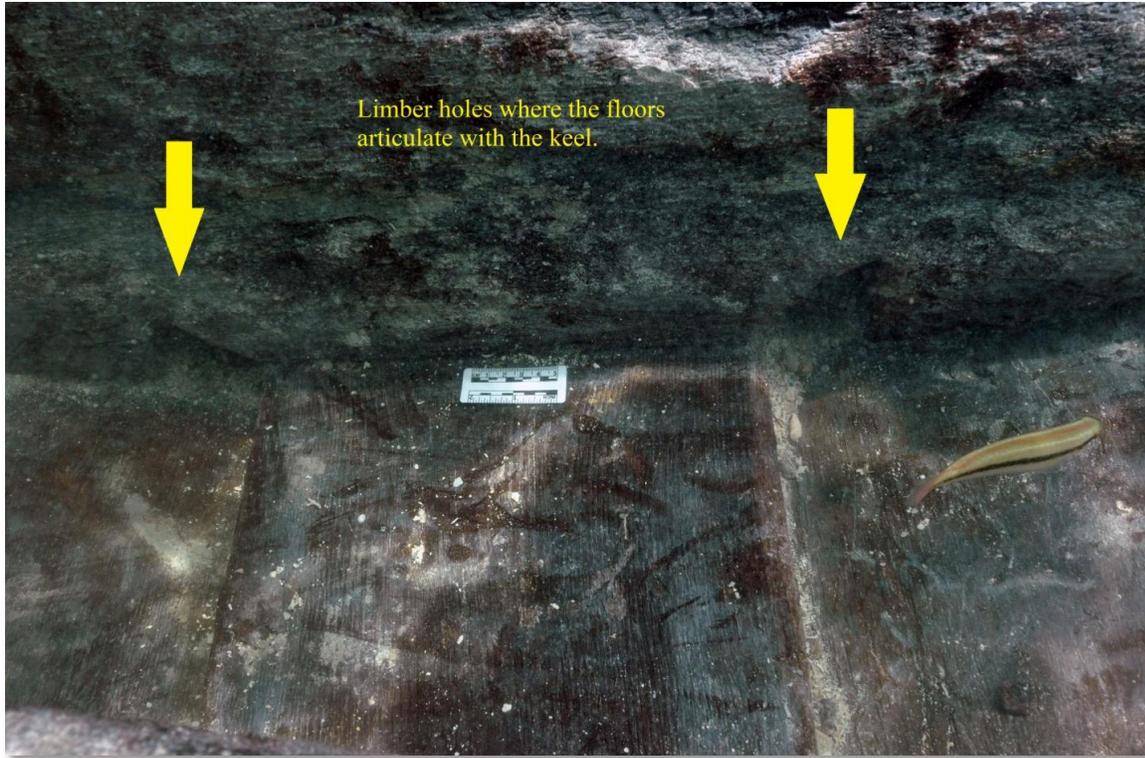
FIGURE 11. Detail of the floor timber limber holes. (Courtesy of the National Park Service, 2012.)

The floors are articulated at the keel with space measuring from 31-34 cm (12.20-13.39 in.) with the average being 32 cm (12.60 in.). At the point of attachment to the keel a shallow (4 cm [1.57 in.]) notch was cut out to accept the keel as it sits proud of the garboard strakes. On either side of the shallow notch is a triangular cut out that, when the floor is placed over the keel, forms a triangular limber hole on either side of the keel (Figure 11). The scantlings for the floors and futtocks were sometimes indeterminate, as sea grass or excess sand obscured the dimensions. Researchers did, however, measure all scantlings they could access. The sided dimensions of the floors vary from 17.2 cm (6.77 in.) to 22.9 cm (9.02 in.) with the average being 19.77 cm (7.78 in.). Consequently, the average room and space for the floors is 51.77 cm (20.38 in.). The molded dimensions are much more variable as the true original dimension was often eroded away, particularly right above the keel, which was the most consistently accessible location from which to measure the timbers. Still, the molded measurements vary from 28.3 cm (11.14 in.) to 42 cm (16.54 in) with the average of those measureable being 35.09 cm (13.81 in.).

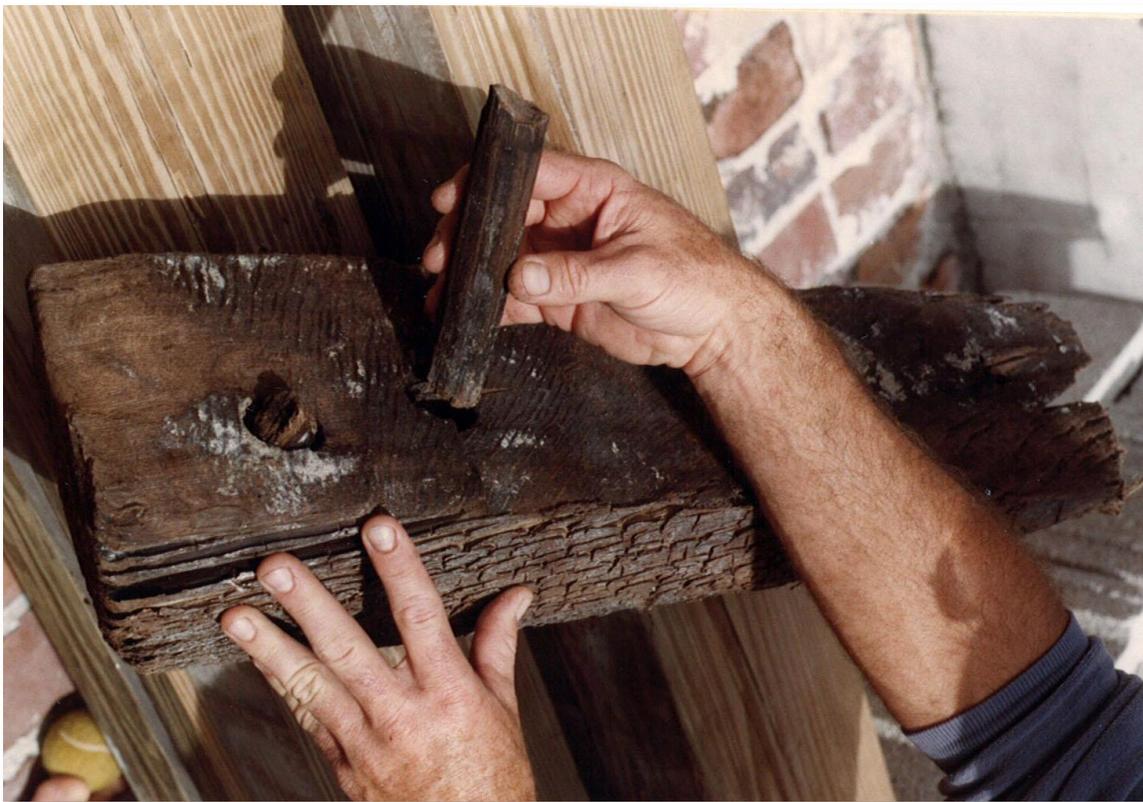
FIGURE 12. Fillet from 1980s from the Soldier Key Wreck. (Courtesy of the National Park Service, 2012.)

use smaller compass timbers and build the dimensions up using the fillets (VanHorn 2004:92,102,106,184,185). Only a few small, badly eroded pieces of wood that once comprised the fillets are still present. Photos exist, however, from Biggers that show a fillet that was loose, or more likely, forcibly removed from the Soldier Key Wreck (Figure 12). This particular construction feature is worth mentioning as the fillets on the Soldier Key Wreck did not appear to have saved much wood at all (they are only around .5 m [19.68 in.] long, and at their thickest end are around 10 cm [3.93 in.]). They may have just become a standard construction feature of whichever shipyard built the vessel. The use of fillets occurs almost exclusively on British shipwrecks (VanHorn 2004:188).

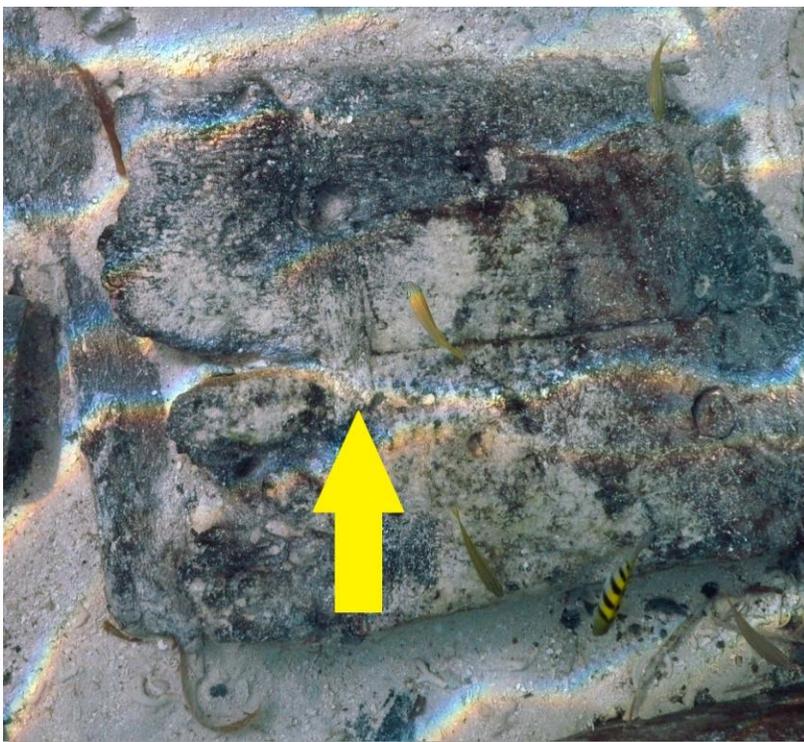
FIGURE 13. Mold frame (floor number 3 and futtock number 4) transverse attachment.
(Courtesy of the National Park Service, 2012.)

The spacing for the futtocks was inconsistent with only a single definitive mold frame evident (floor number 3 and futtock number 4). Divers uncovered a single transverse wooden fastener that attaches these two timbers (Figure 13). While the proximity of the futtocks and floors varied, and no other transverse fasteners were observed, floor number 8 and futtock number 8 also appear to be paired. This arrangement suggests that every fifth pair of timbers represents a mold frame. Interestingly, in the definitive mold frame, the frame is attached aft of the floor. In the pairing of floor and futtock number 8, the futtock was attached forward of the floor. This construction feature often marked the midships of a vessel and has been seen in ship construction from the earliest ships of Spanish exploration in 1559 (Smith et al. 1999:32–34) to the 1814 wreck of the *Nancy* (Sabick 2004:93).

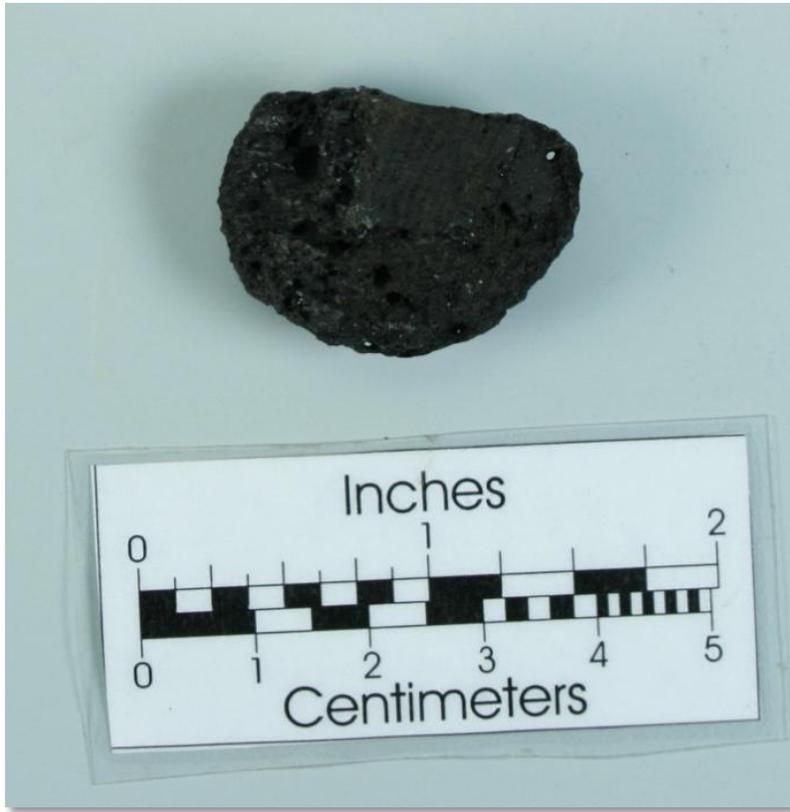
FIGURE 14. BISC 621. A pegged treenail recovered from the Soldier Key Wreck. (Courtesy of the National Park Service, 2012.)

Aside from iron drift pins that attached the floors to the keel, all of the extant components of the vessel were fastened entirely with 3.18 cm (1.25 in.) diameter octagonal wooden treenails. Many, like the rest of the exposed wood, were badly eroded. Several treenails collected from the site, however, exhibit pegged ends (Figure 14). Whether all of the treenails were pegged is unclear (many treenails are missing and the tight pegs in the end grain of wood are difficult to discern underwater), or perhaps only one side, interior or exterior, was pegged. Pegged ends were not always necessary and show a greater degree of care and a greater investment of time in the construction of the vessel (McCarthy 2005:68).

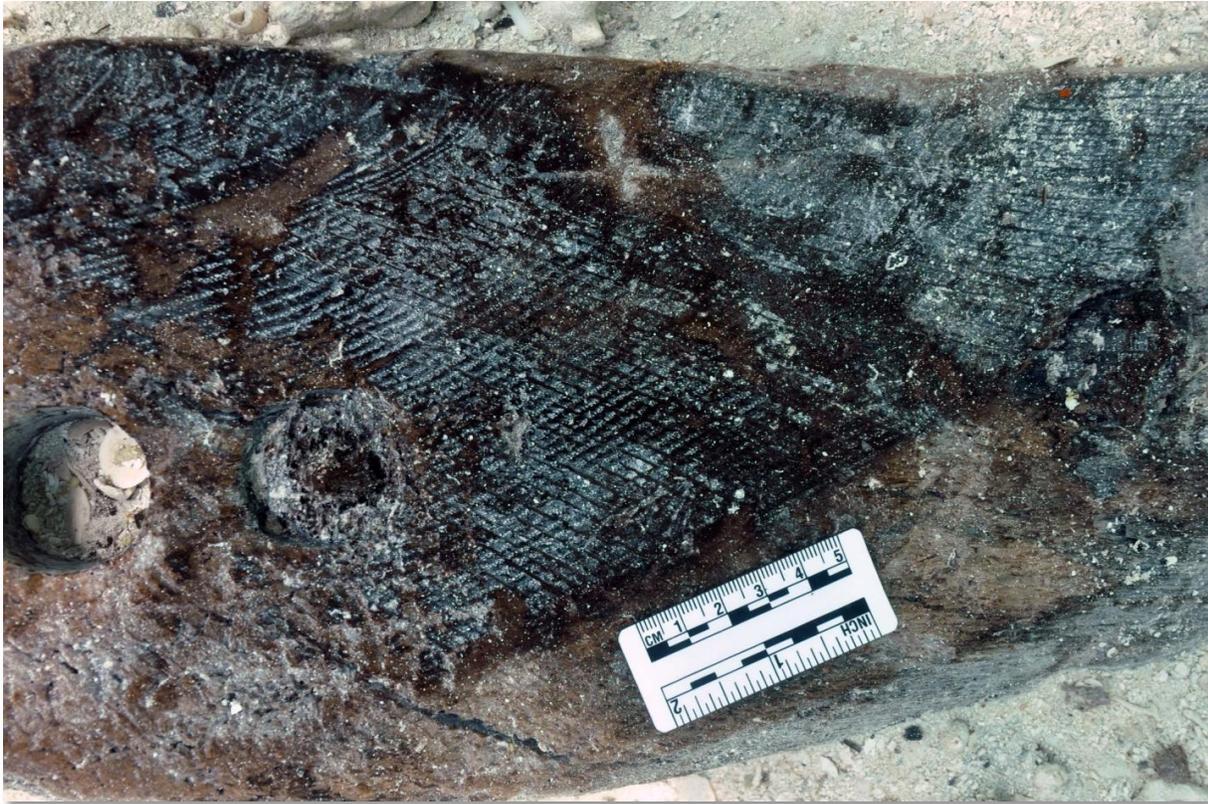
FIGURE 15. Saw marks on the proximal end of second futtock number two. (Courtesy of the National Park Service, 2012.)

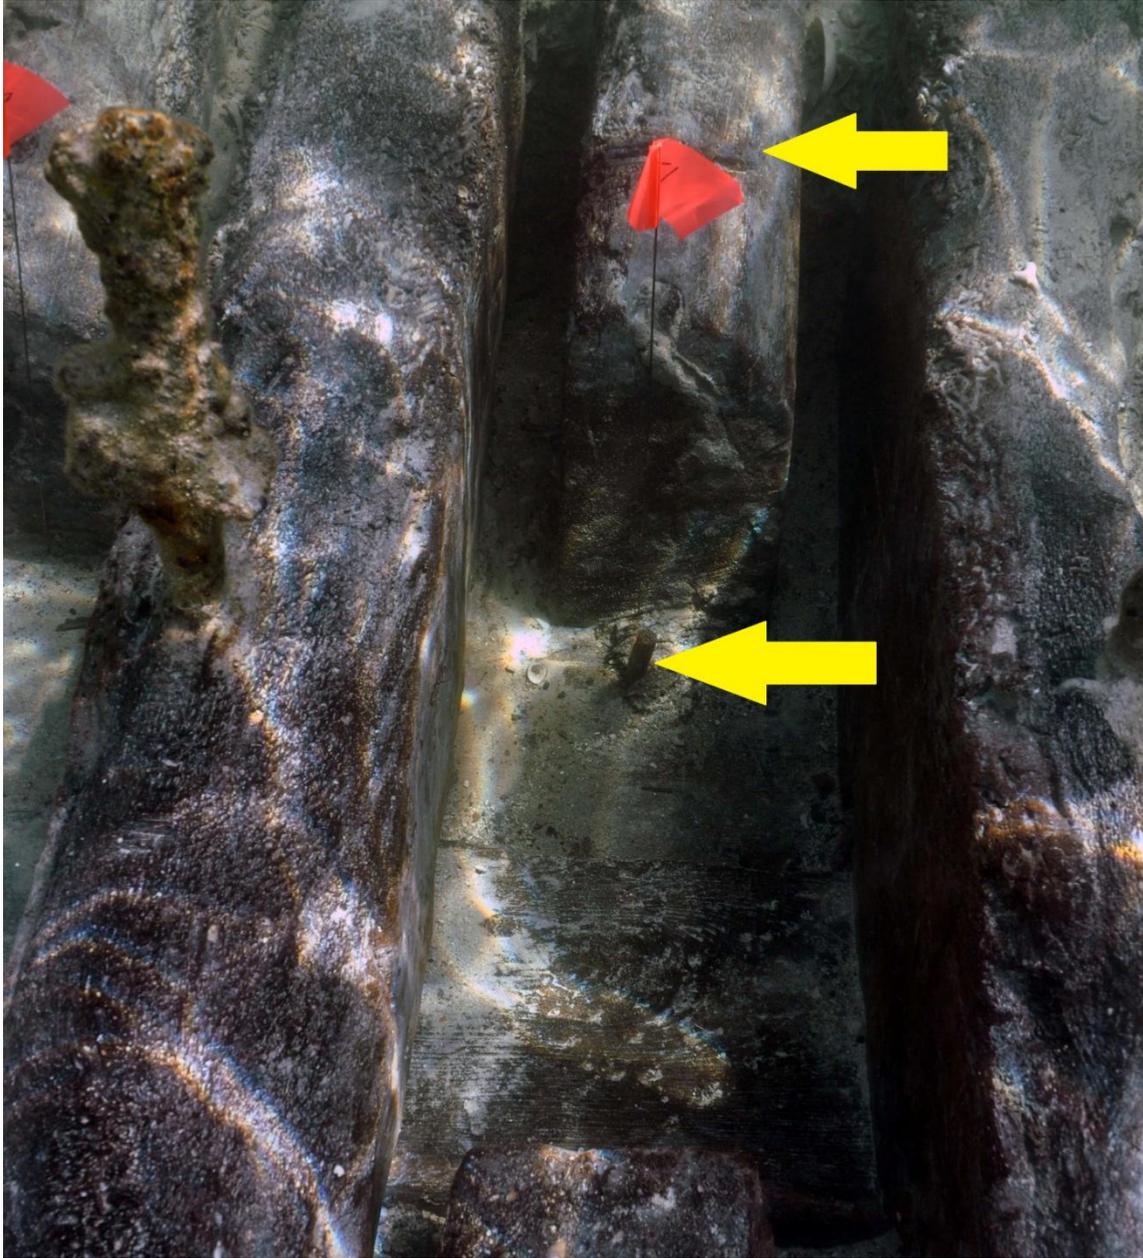
FIGURE 16. Detail of the saw kerf on floor number 10 and the small treenail in the starboard (north) garboard strake. (Courtesy of the National Park Service, 2012.)

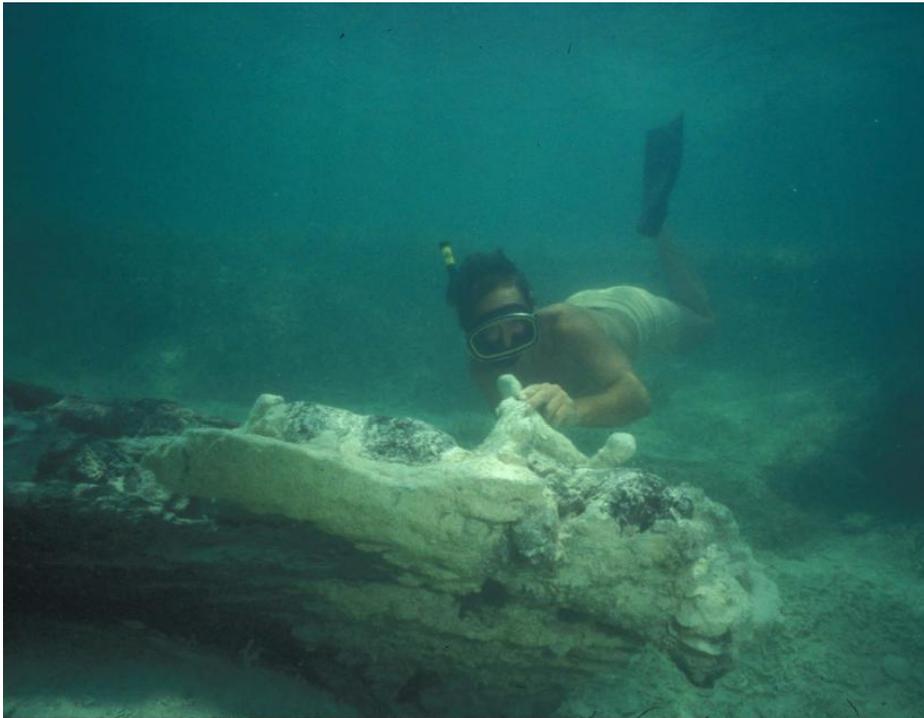
FIGURE 17. Soldier Key Wreck stern with probable gudgeon. (Courtesy of the National Park Service, 2012.)

not have been involved in the looting of the vessel, clearly show the stern of the vessel in what appears to be various levels of articulation. The stern appears to be built heavily, lacked cant frames in its construction, and may have had at least one gudgeon in place when photographed (Figure 17). Comparing photographs from Biggers and those given to park volunteer Terry Helmers by an unknown source after he presented a talk to sport divers about the resources in the Park, researchers can track the aforementioned disarticulation of the stern section. In the photos recovered from Biggers, the stern is intact and articulated with the rest of the wreck (Figure 18). In the subsequent donated photographs, the stern is listing hard to port, the opposite side to which the rest of the vessel is listing (Figure 19). Whether this damage was anthropogenic, related to storm events, or more likely the result of both, is unknown, as is what happened to the stern.

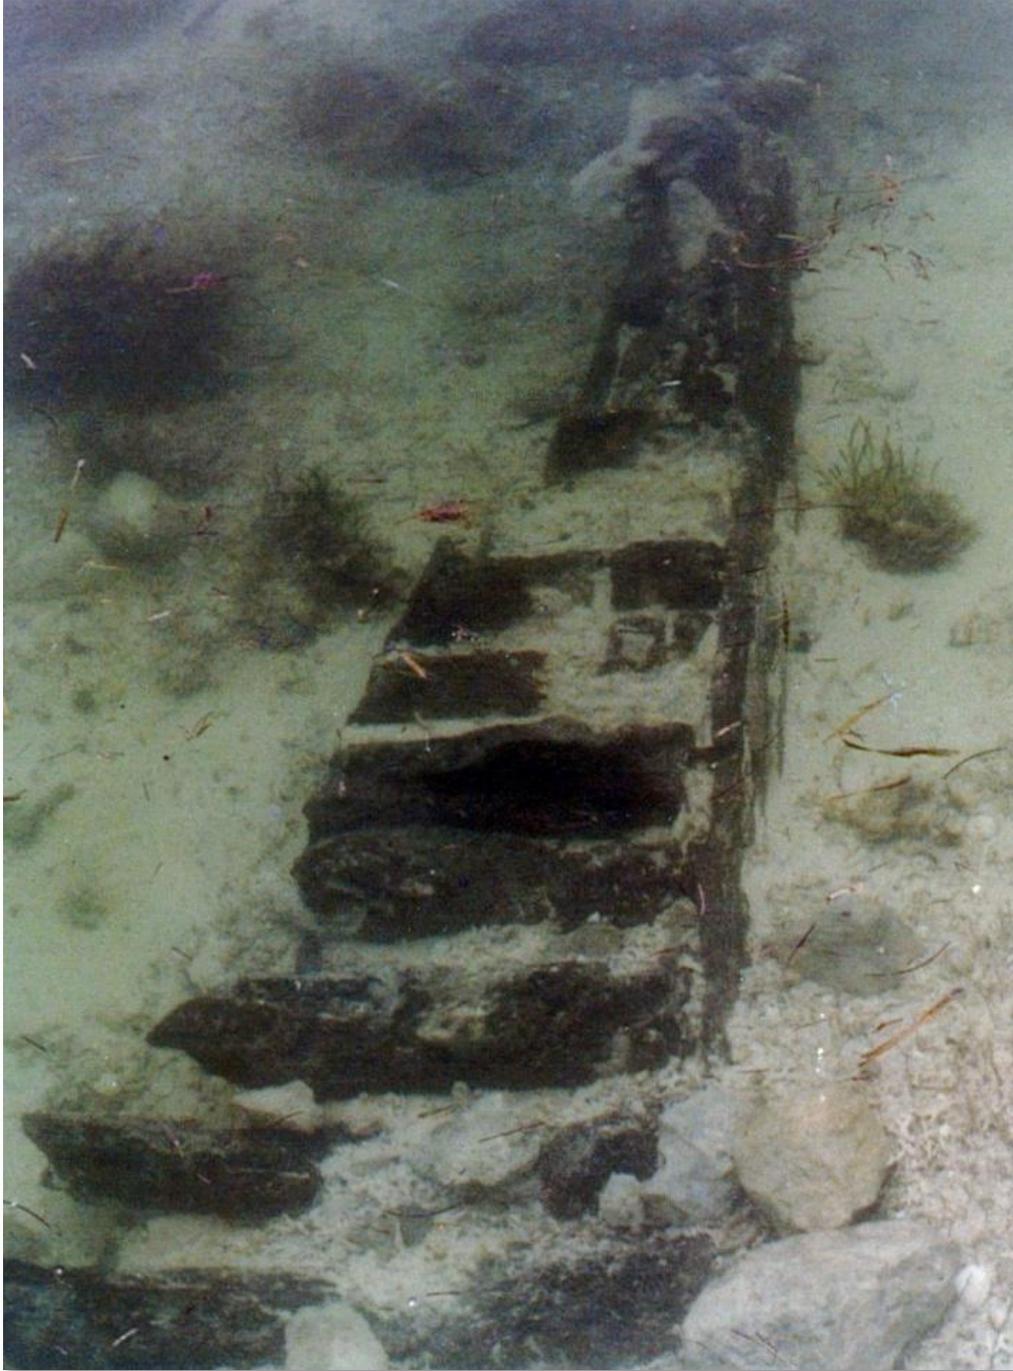
FIGURE 18. Photograph from the Biggers collection showing the articulated stern. (Courtesy of the National Park Service, 2012.)

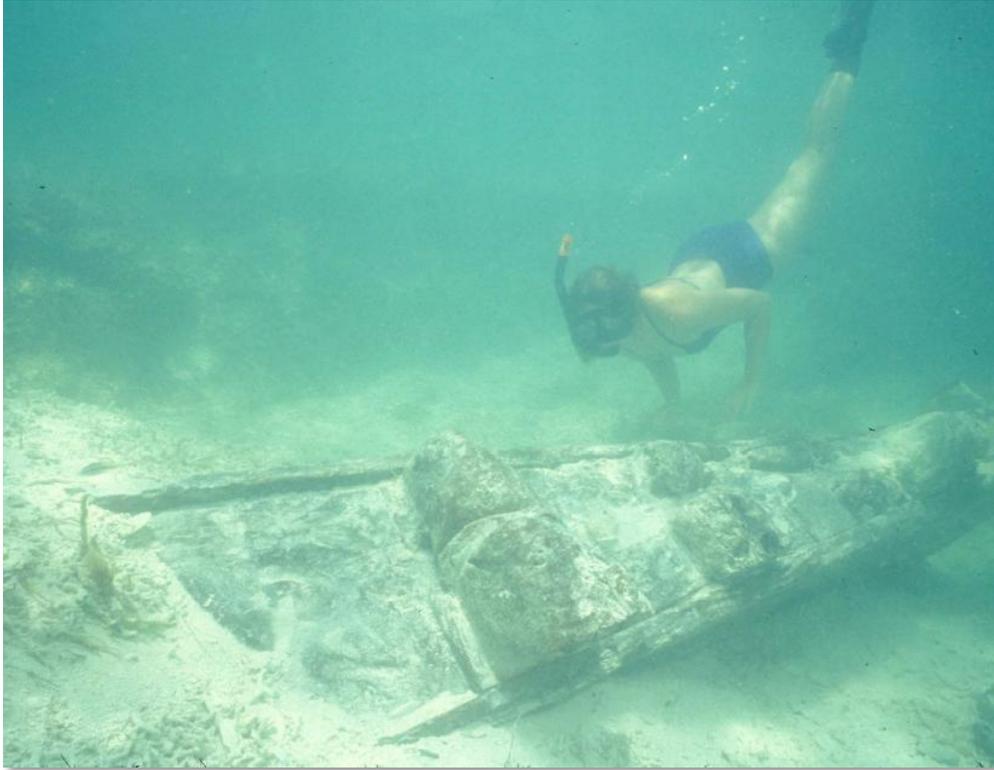
FIGURE 19. Soldier Key Wreck stern listing to port. (Courtesy of the National Park Service, 2012.)

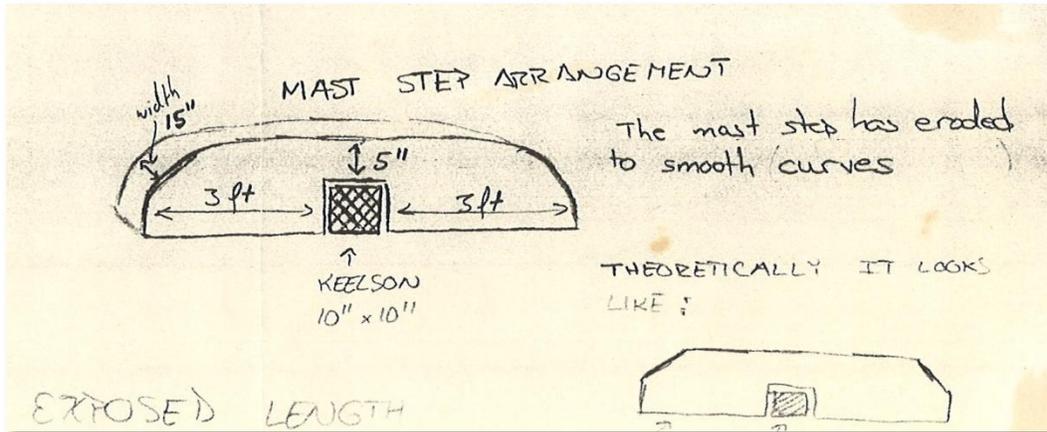
FIGURE 20. Hall's 1980s drawing and notes on the mast step. (Courtesy of the National Park Service, 2012.)

While not present during the 2012 excavation, Biggers' photos and notes provide evidence of a large saddle mast step (Figures 20 and 21) and a significant length of keelson, though the keelson did not run the length of the vessel, having eroded or been broken off aft of the mast step but prior to the stern. There was no indication of where the mast step had been during the 2012 fieldwork; fortunately, however, photographs and the little bit of information from Hall's work provide an idea of where the keelson extended and, consequently, where the mast step was located.

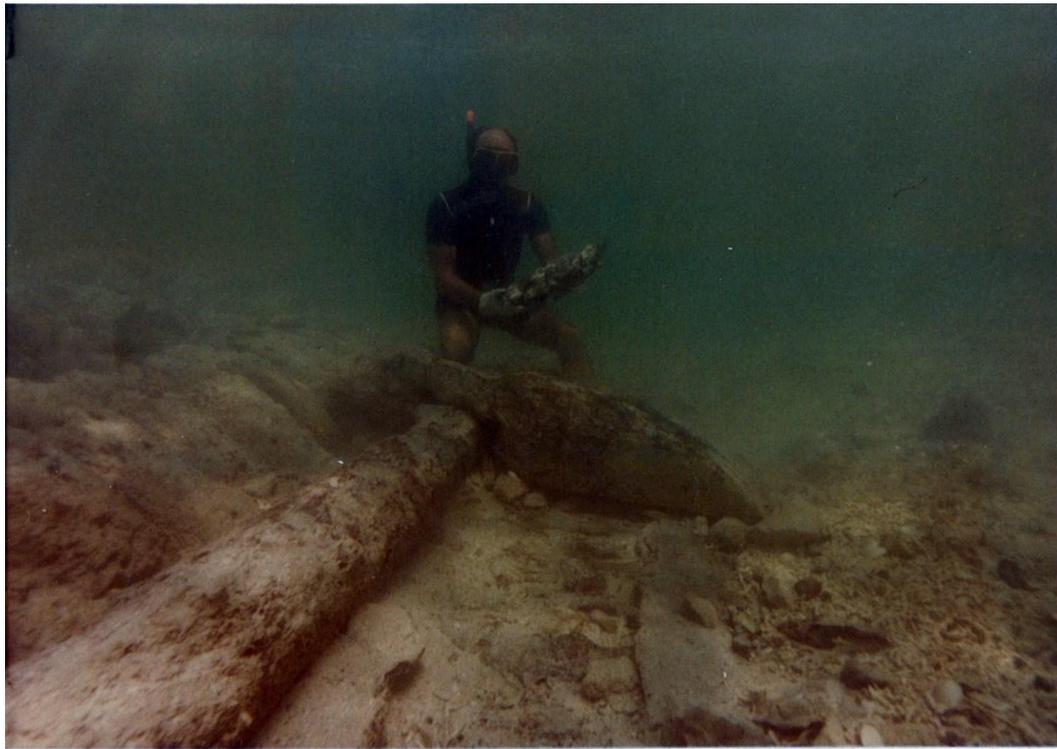
FIGURE 21. 1980s photograph of the mast step from the Soldier Key Wreck. (Courtesy of the National Park Service, 2012.)

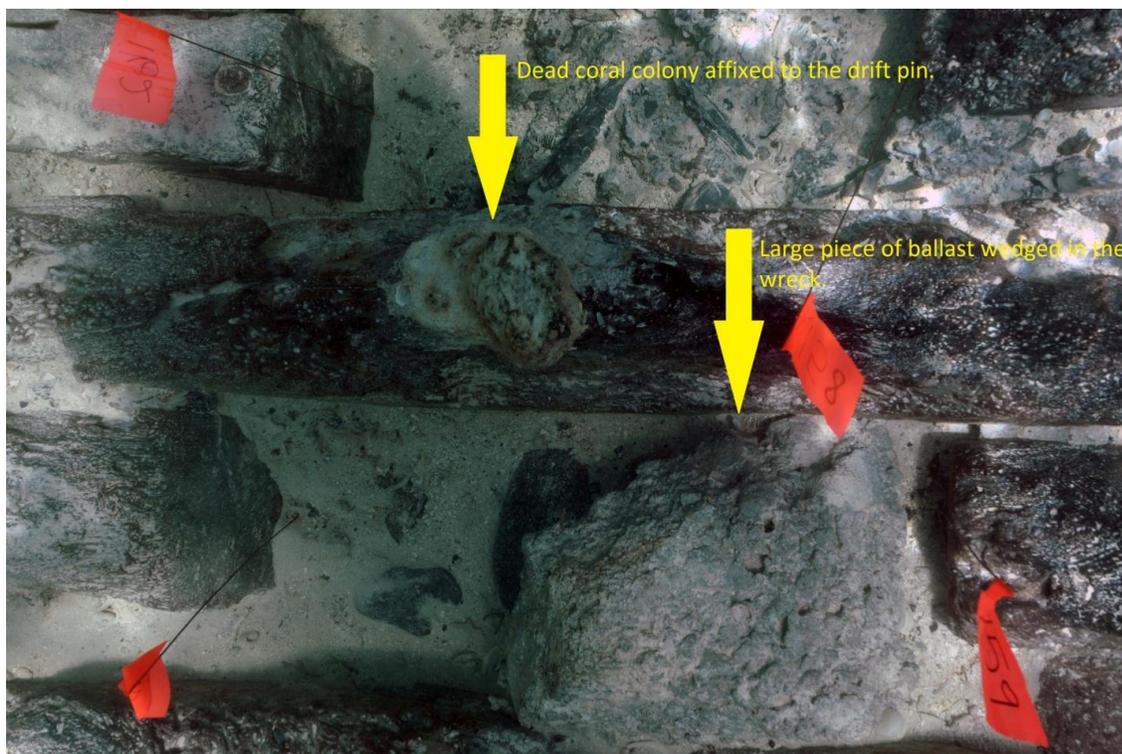
FIGURE 22. Photograph taken during the 2012 excavation showing the coral colony and large piece of ballast wedged between the floors of the wreck. (Courtesy of the National Park Service, 2012.)

heavy, wedged in rather tightly, and removing it likely would have damaged the wreck. The aft floor that framed the large ballast stone, floor number 12, had another unique feature. Around the drift pin that would have attached the keelson to the keel and secured the floors between the two timbers, was a dead coral colony. While some other drift pins and floors had small living corals affixed to them, this was the only drift pin/floor that possessed this particular trait (Figure 22). Auspiciously, some of the photographs donated to the Park Service by the anonymous diver show all three of these features, the coral colony, the large ballast stone, and the terminal end of the keelson, in a single photograph. Consequently, researchers can determine where the keel that used to be present extended, and therefore can deduce where the mast step was located (Figure 23).

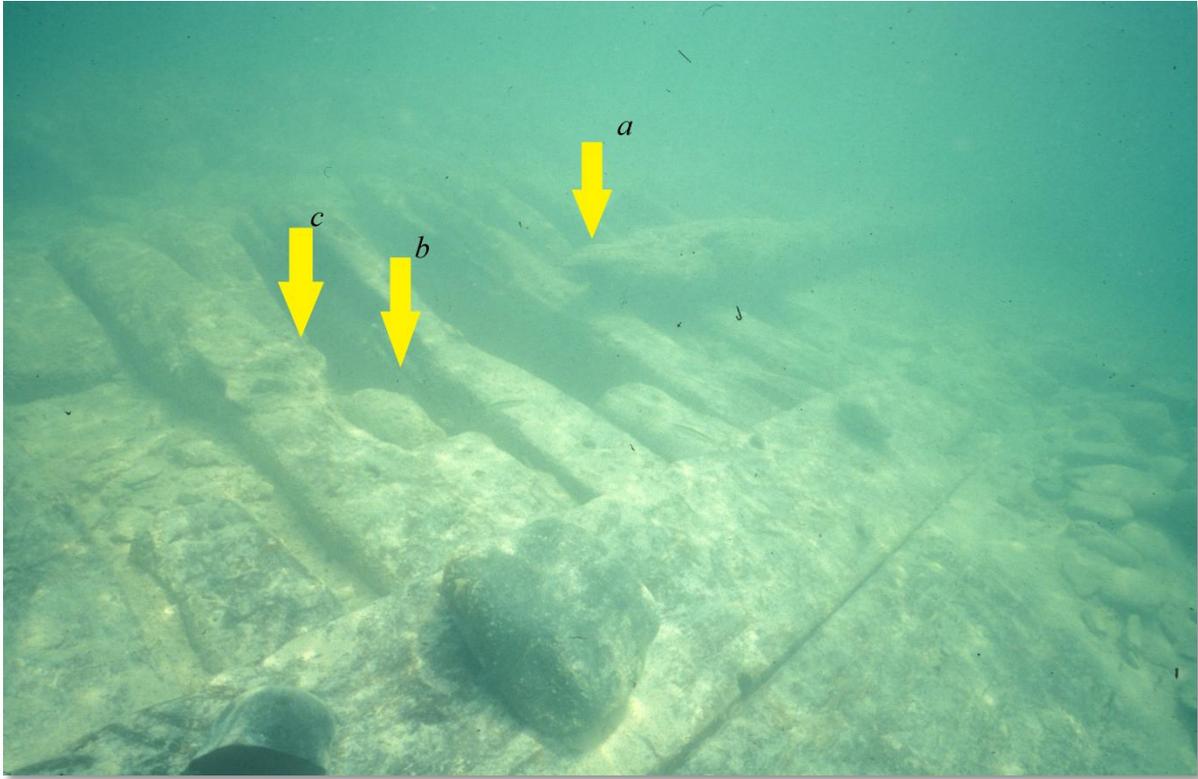
FIGURE 23. Photograph from the 1980s showing the terminal end of the extant keelson (*a*), the large wedged ballast (*b*), and the coral colony around the drift pin (*c*). (Courtesy of the National Park Service, 2012.)

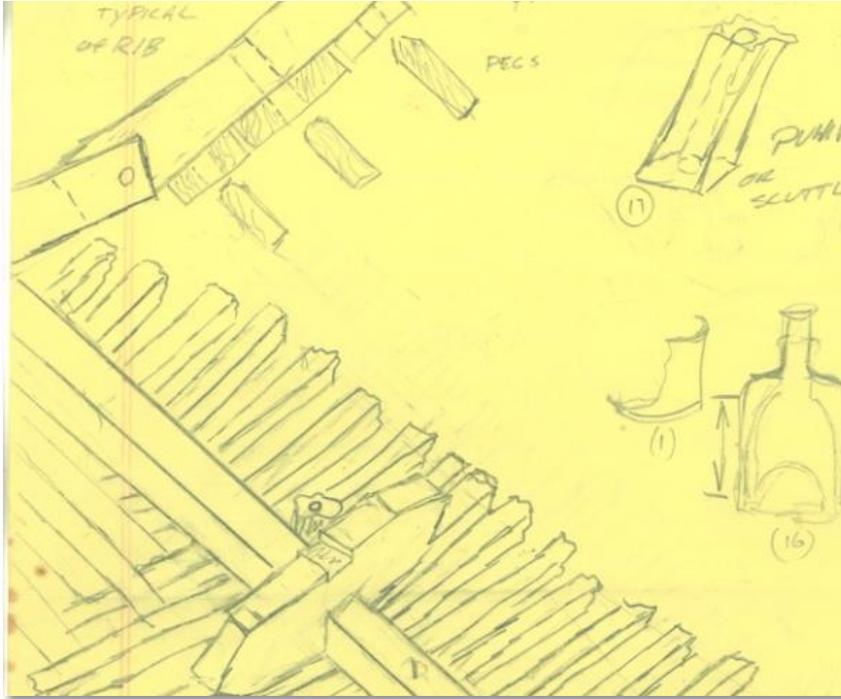
FIGURE 24. Isometric drawing from the Biggers collection showing the pump in place.

The Soldier Key Wreck is no exception and evidence of a pump was discovered in the early investigations. Documentation from the 1980s work on the site mentions a pump aft of the mast step on the port side of the vessel (Figure 24) and in Biggers' donated photographs is an artifact that may be the pump well (Figure 25). Because excavators found no evidence of the pump well during the 2012 excavation, all information researchers can glean from the pump comes from the isometric drawings and photographs from Biggers. The actual artifact from the Biggers collection was not returned to the National Park Service.

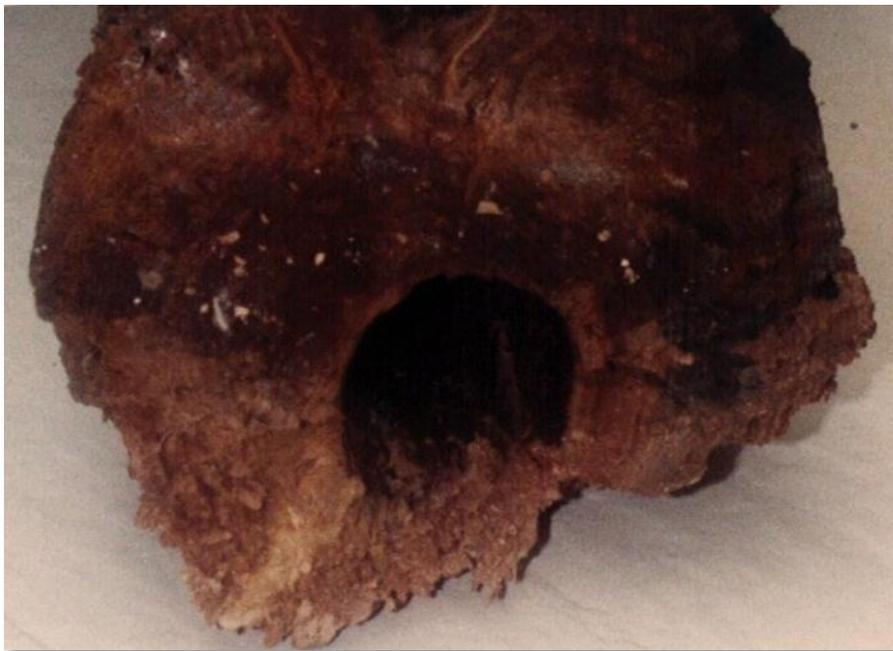
FIGURE 25. Photograph of possible pump taken by Doug Biggers in the 1980s. (Courtesy of the

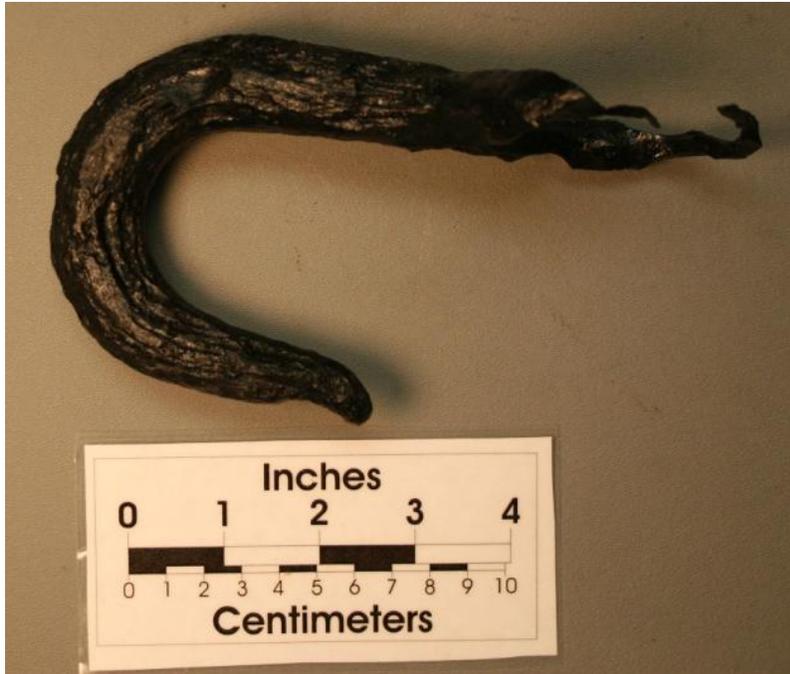
FIGURE 26. BISC 661. Fixed-eye hook. (Courtesy of the National Park Service, 2012.)

The rigging components, as with all of the artifacts, are few and lack provenience. The majority of rigging components recovered is in the lot of artifacts that Doug Biggers returned to the Park. In this lot, Biggers returned two iron hooks, one with a swivel eye (BISC 660) (Figure 26) and one with a fixed eye (BISC 661) (Figure 27). BISC 660, the swivel hook, also had a hole in the tip of the hook, likely to aid in “mousing”—lashing around a hook to hold a load fast (Biddlecombe 1990:21).
