A FINE WRECK IN SHALLOW WATER: INVESTIGATION INTO,
AND CONSERVATION OF, A HEAVILY DISTURBED
18TH CENTURY BRITISH WEST INDIAMAN,
THE SOLDIER KEY WRECK

A thesis submitted to the Department of Anthropology
College of Arts, Social Sciences, and Humanities
The University of West Florida
In partial fulfillment of the requirements for the degree of
Master of Arts

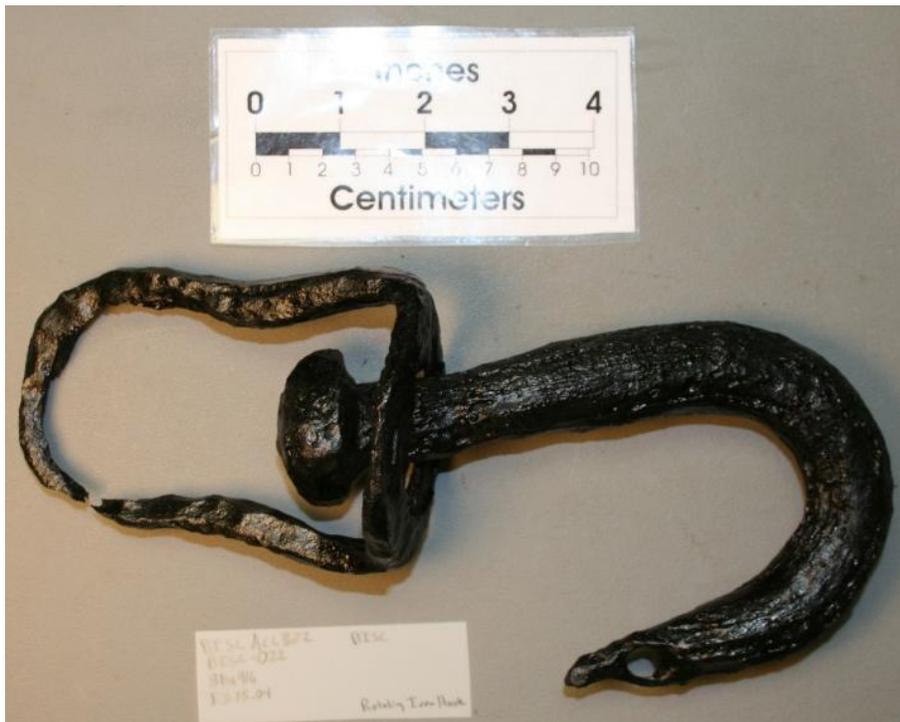
FIGURE 27. BISC 660. Swivel eye hook with mousing hole. (Courtesy of the National Park Service, 2012.)

The rigging components, as with all of the artifacts, are few and lack provenience. The majority of rigging components recovered is in the lot of artifacts that Doug Biggers returned to the Park. In this lot, Biggers returned two iron hooks, one with a swivel eye (BISC 660) (Figure 26) and one with a fixed eye (BISC 661) (Figure 27). BISC 660, the swivel hook, also had a hole in the tip of the hook, likely to aid in “mousing”—lashing around a hook to hold a load fast (Biddlecombe 1990:21).

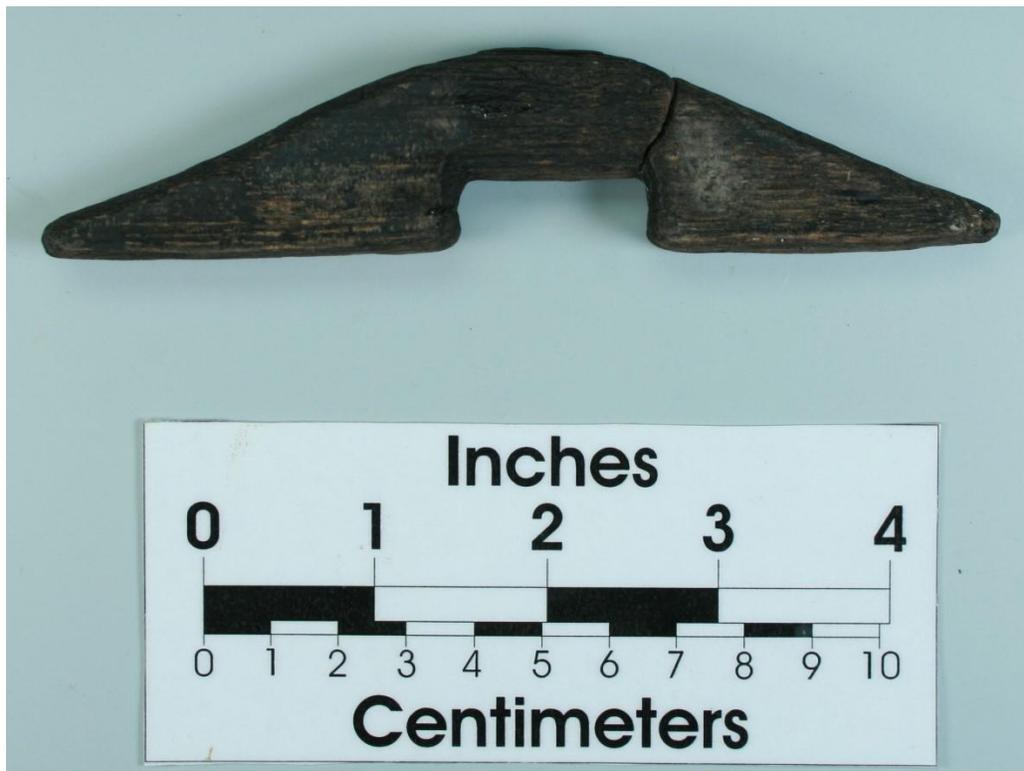
FIGURE 28. BISC 648. Probable comb cleat. (Courtesy of the National Park Service, 2012.)

The only other real possibility is that it is a handle of some kind. The artifact lacked any evidence of attachment points and showed no obvious wear. A small piece of iron was, however, protruding from one side of the artifact slightly off center. Radiography of the artifact showed that the iron was not part of a fastener, did not protrude to the other side of the artifact, and was likely embedded during the wrecking event or during the time the artifact spent in the bilge. It may have been a new, unused shroud cleat that would be finished when required and grooved to the particular shroud where it was needed, though the most likely explanation is that the artifact is a comb cleat, albeit a small one. Such a comb cleat may have been used on the ship's boat, rather than the larger vessel.

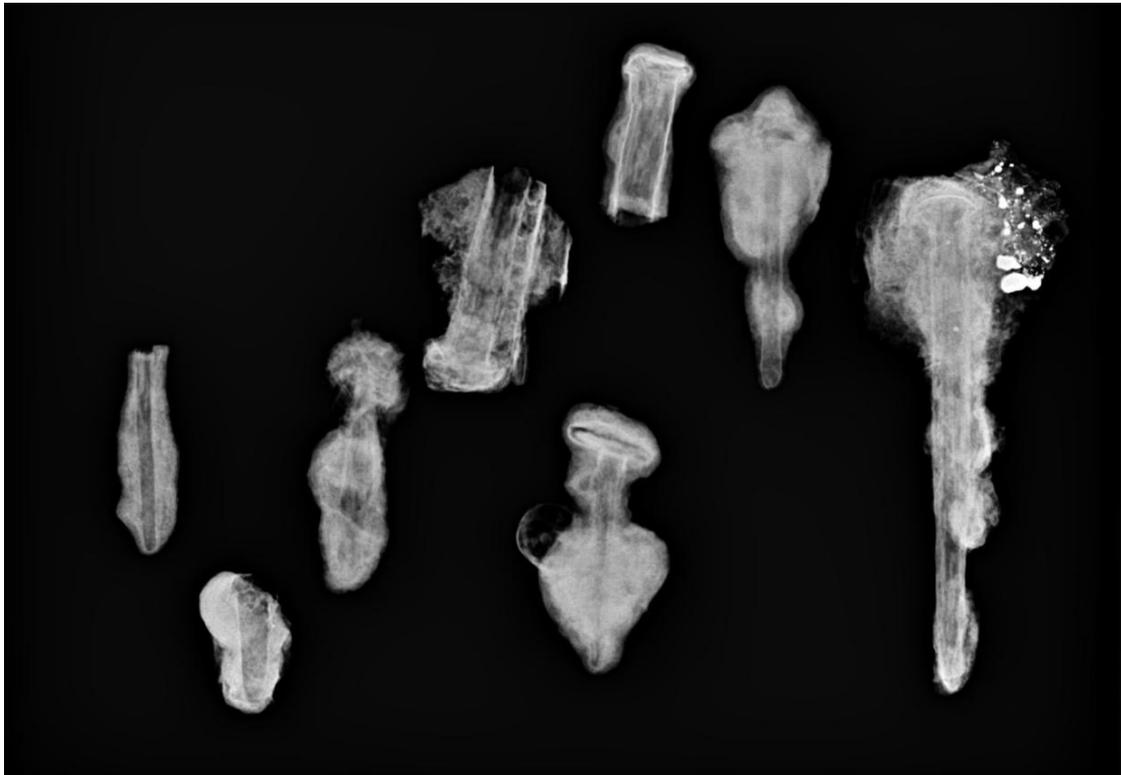
FIGURE 29. X-ray of several concreted fasteners from the Soldier Key Wreck showing the diversity of fastener types used. (Image by author, 2013.)

Wooden treenails were the only fasteners visible in the interior of the extant hull with the exception of the iron drift pins that fastened the keelson, floors, and keel together. However, concreted iron fasteners were recovered during the 2012 excavation. Wooden treenails were preferable below the waterline, but iron fasteners were used in construction of the upper decks and iron sheathing tacks were used to attach the sacrificial sheathing to the hull. Radiography of the concretions revealed that the original iron has long since deteriorated (Figure 29). Along with the x-rays, resin casts made from the hollow concretions revealed that several fastener types and sizes were present, among them a sheathing tack (BISC 595) and several rosehead nails that exhibit spoon tips (BISC 593 and BISC 626).

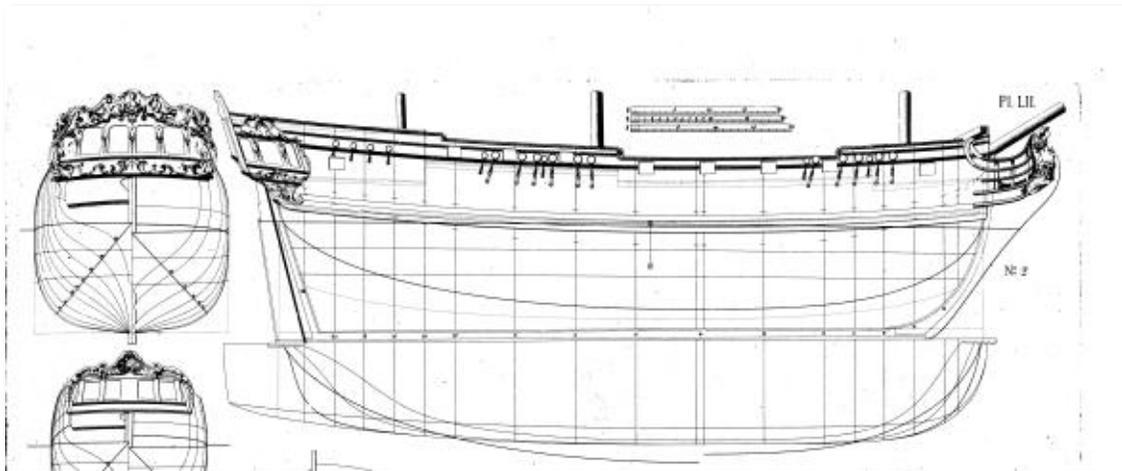
FIGURE 34. Lines drawing of a 1768 "English West India Trader." Plate 52 *Architectura Navalis Mercatoria*, Frederick Henrik AF Chapman, 1768.

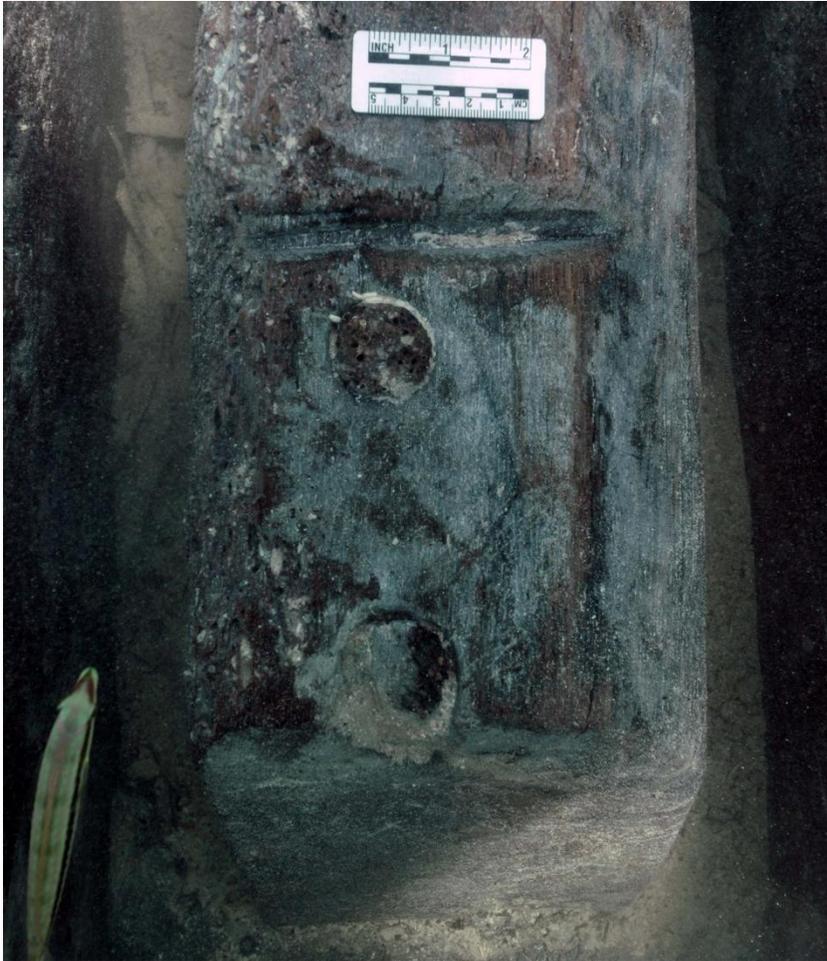
FIGURE 35. Detail of futtock number 10 showing cross-cut. (Courtesy of the National Park Service, 2012.)

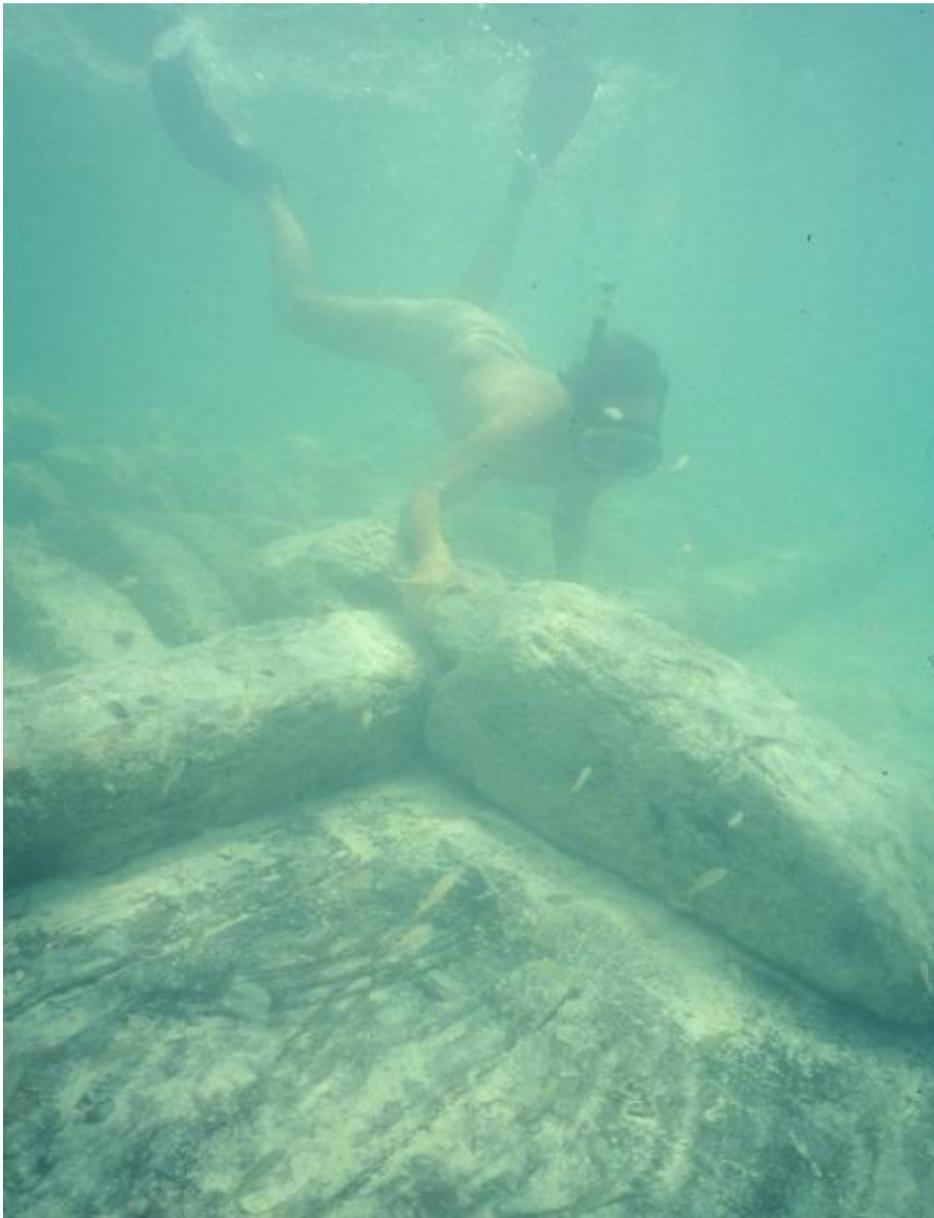
FIGURE 48. Keelson and mast step of the Soldier Key Wreck in the 1980s. (Courtesy of the National Park Service, 2012.)

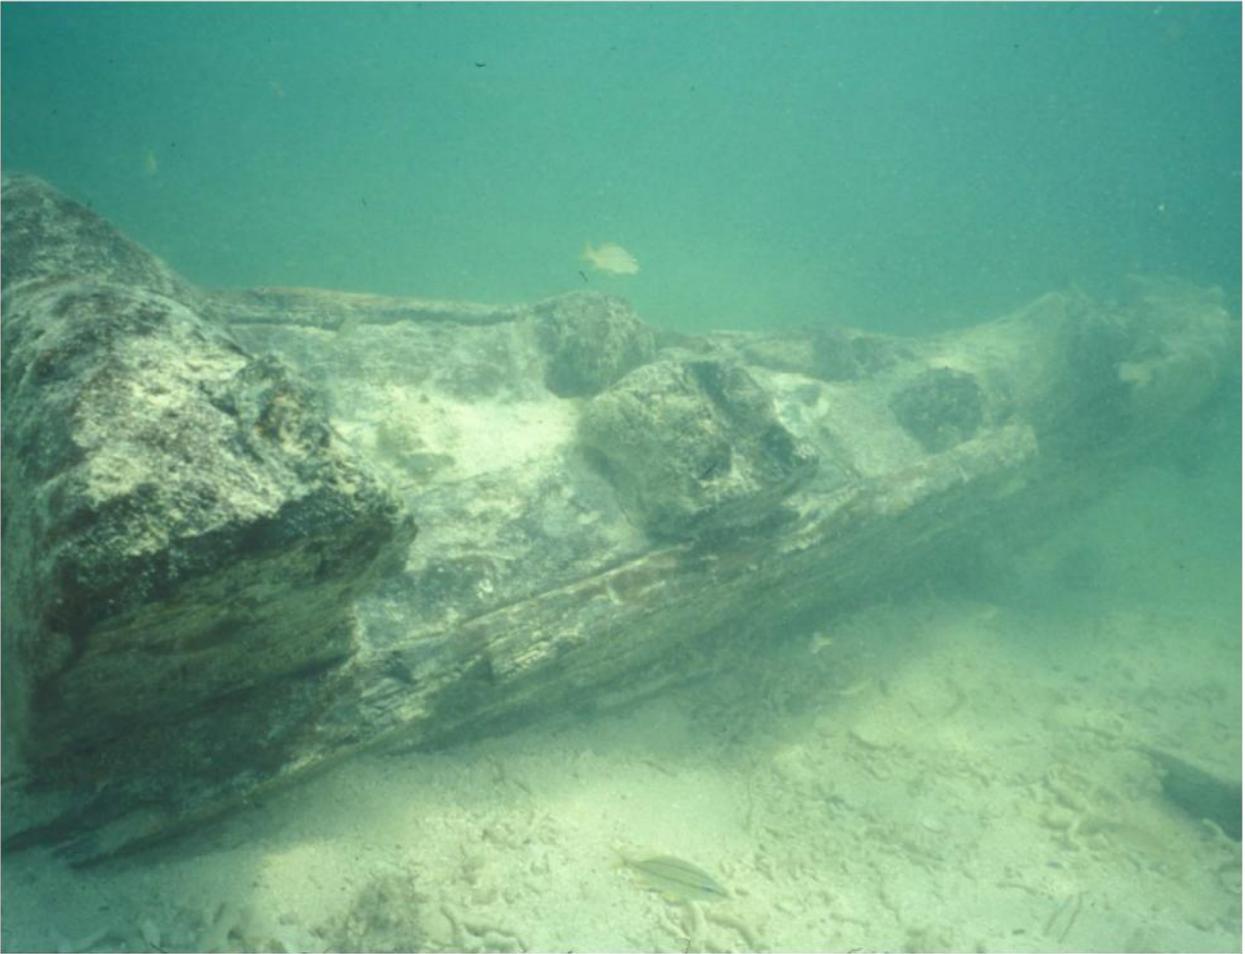
FIGURE 49. Stern of the Soldier Key Wreck in the 1980s. (Courtesy of the National Park Service, 2012.)
